## **Concrete Moisture Control Admixture Technical Bulletin**

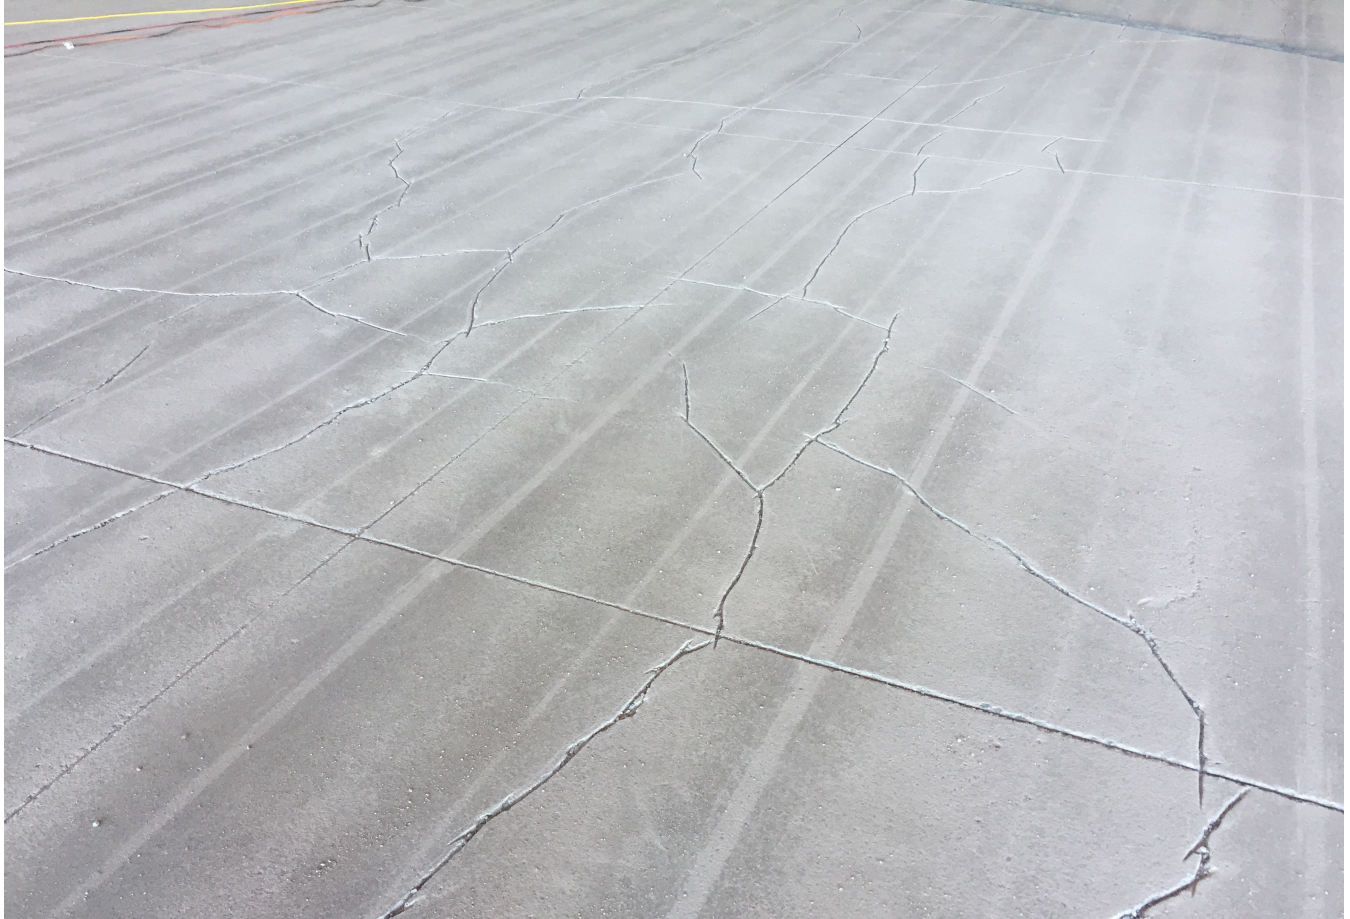
Fig. 1. Moisture control admixture incorporated into the concrete mix design that doubled (3000 PSI to 6600 PSI) the project-specified PSI at 28 days, resulting in major cracking throughout the entire concrete slab that required substantial remediation.

The remediation requirements for a shattered slab in preparation for installing resilient flooring include chasing all cracks so they can be filled with a semi-rigid polyurea joint filler, potentially in conjunction with a two-component resin moisture control system installation to remediate slab moisture conditions. Before the joint filler is installed, all cracks must be routed out with a diamond blade grinder/saw and then thoroughly cleaned and vacuumed. This is a labor-intensive and time-consuming process. Even after remediation, the cracking may cause

issues years later as the slab and cracks widens/shrinks/settles causing joints to pop, causing the cracks to telegraph through the resilient flooring system.
